# General Considerations in Failure Analysis of Rubber

Jason T. Poulton, PhD  
Senior Technical Advisor  
Akron Rubber Development Laboratory

# Akron Rubber Development Laboratory

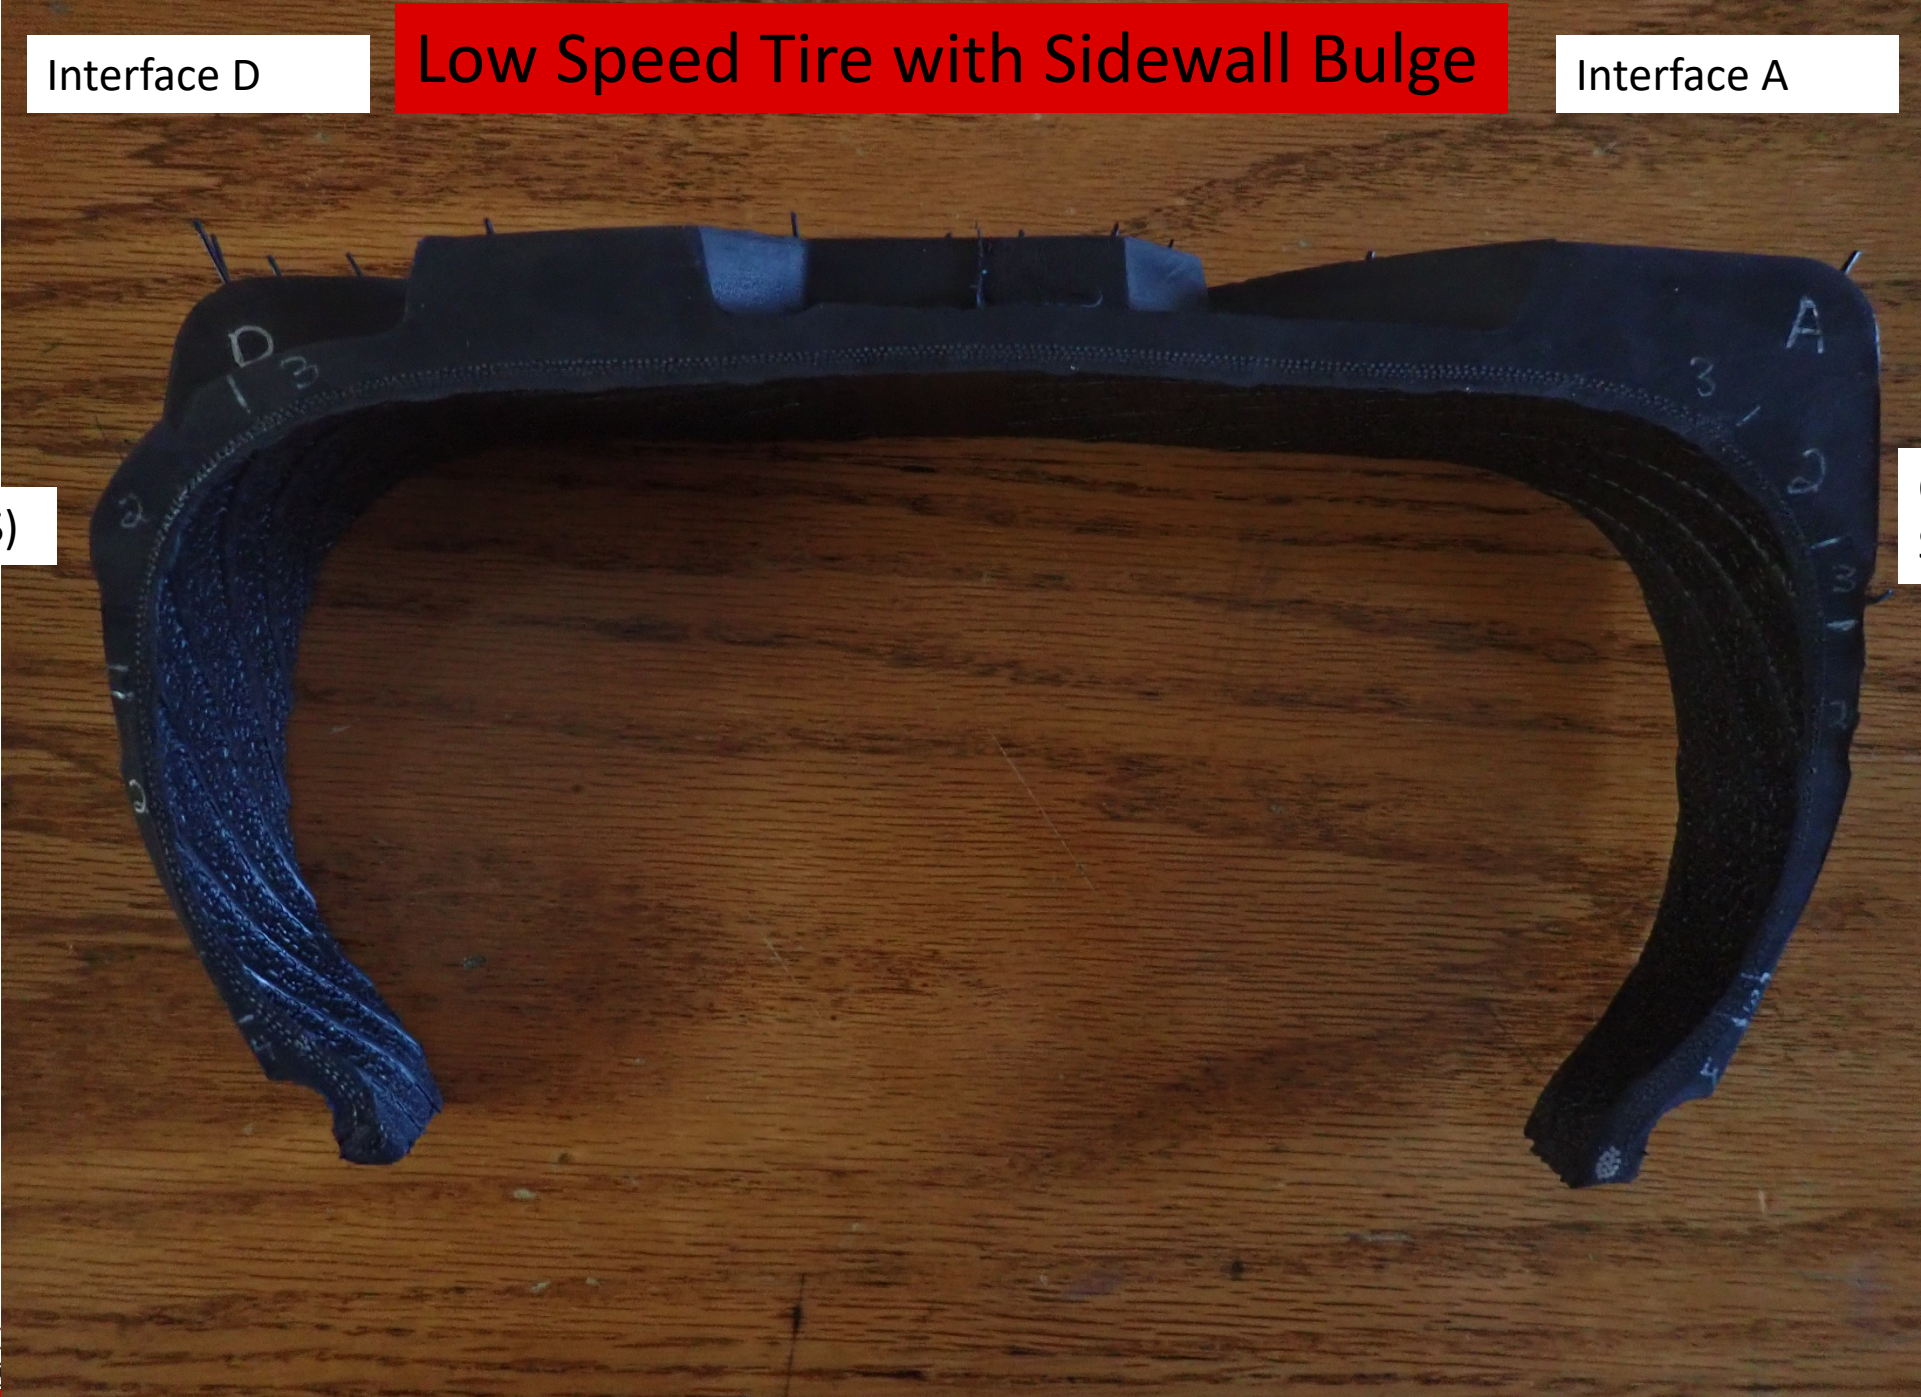
# Low Speed Tire with Sidewall Bulge

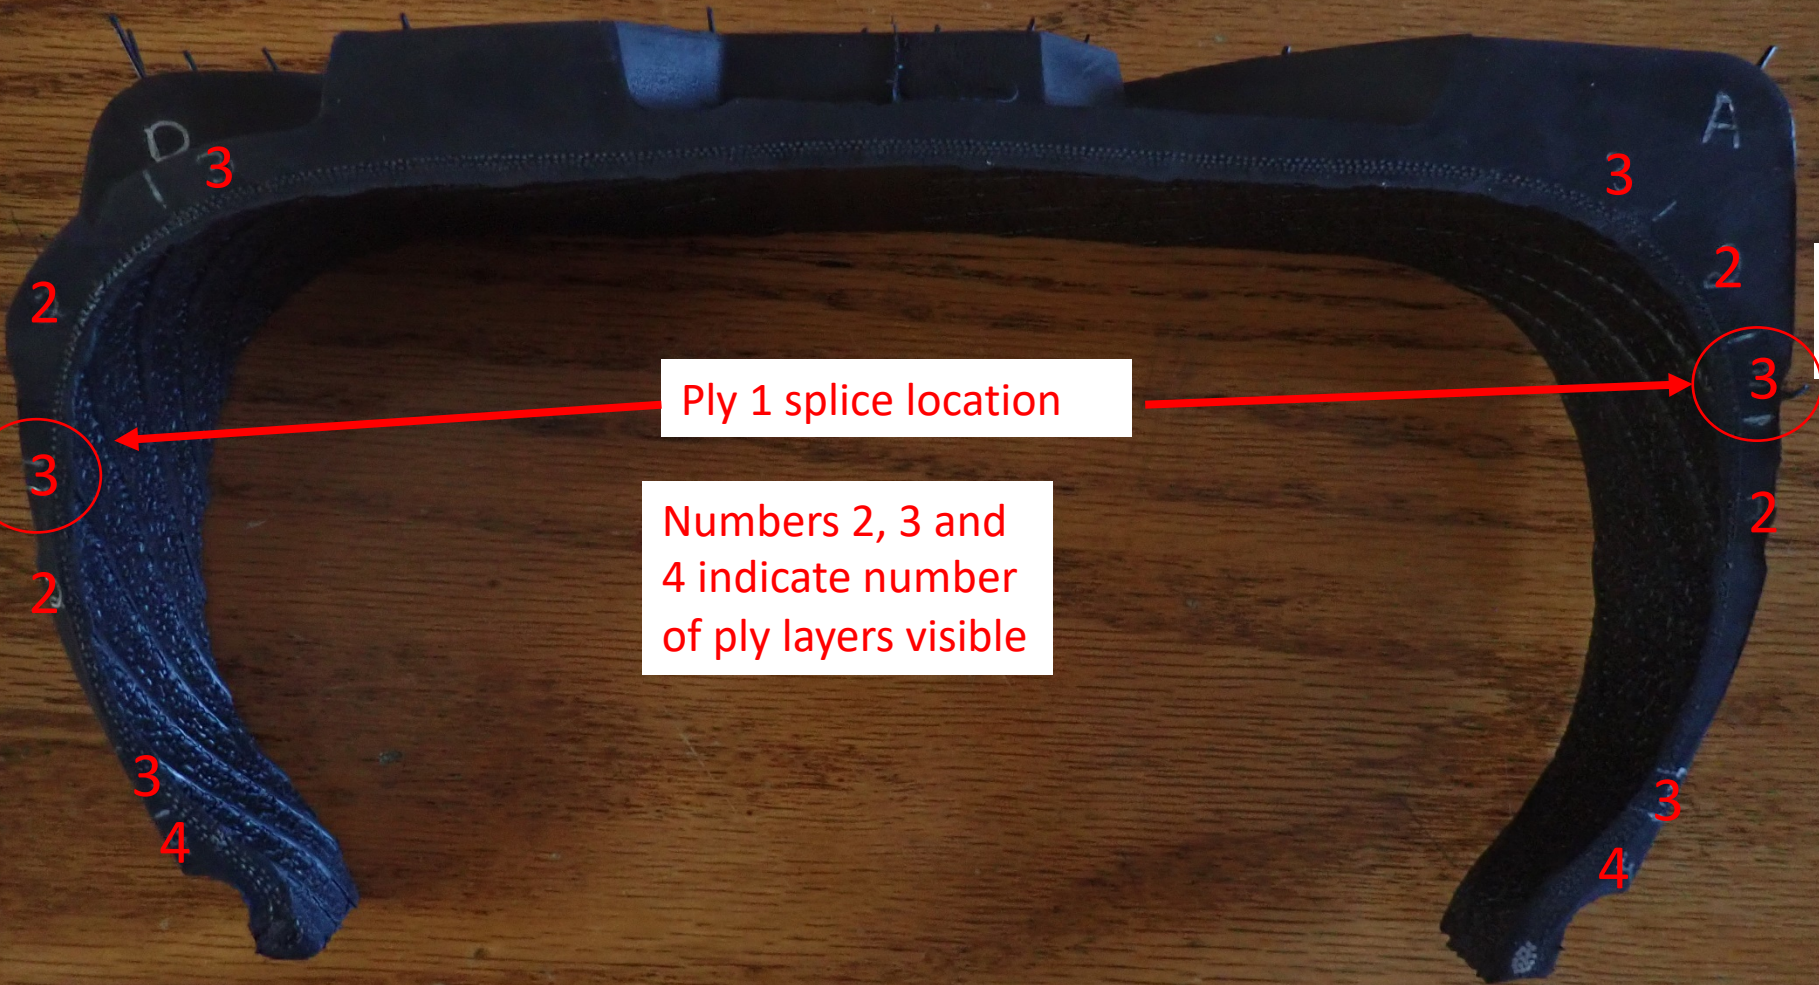
Ply 1 splice location

Numbers 2, 3 and 4 indicate number of ply layers visible

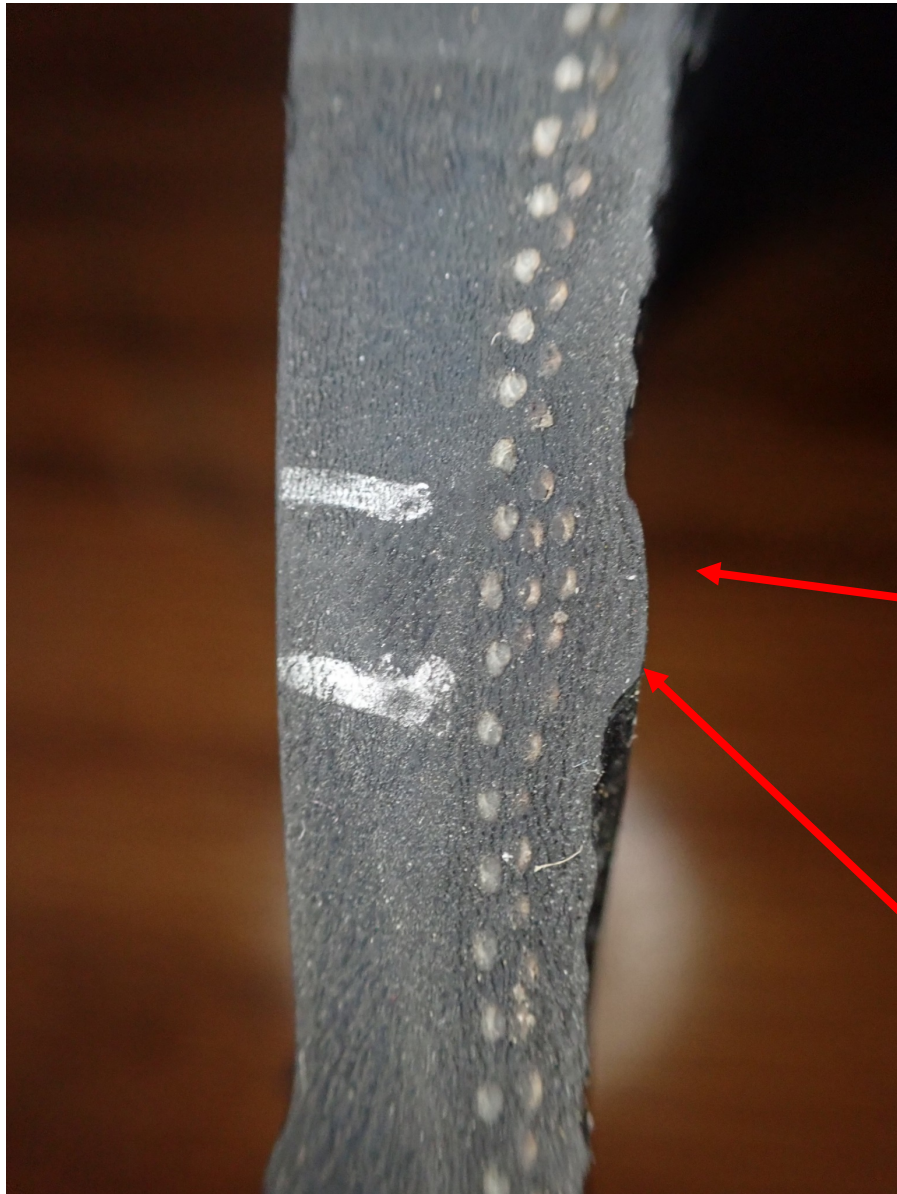
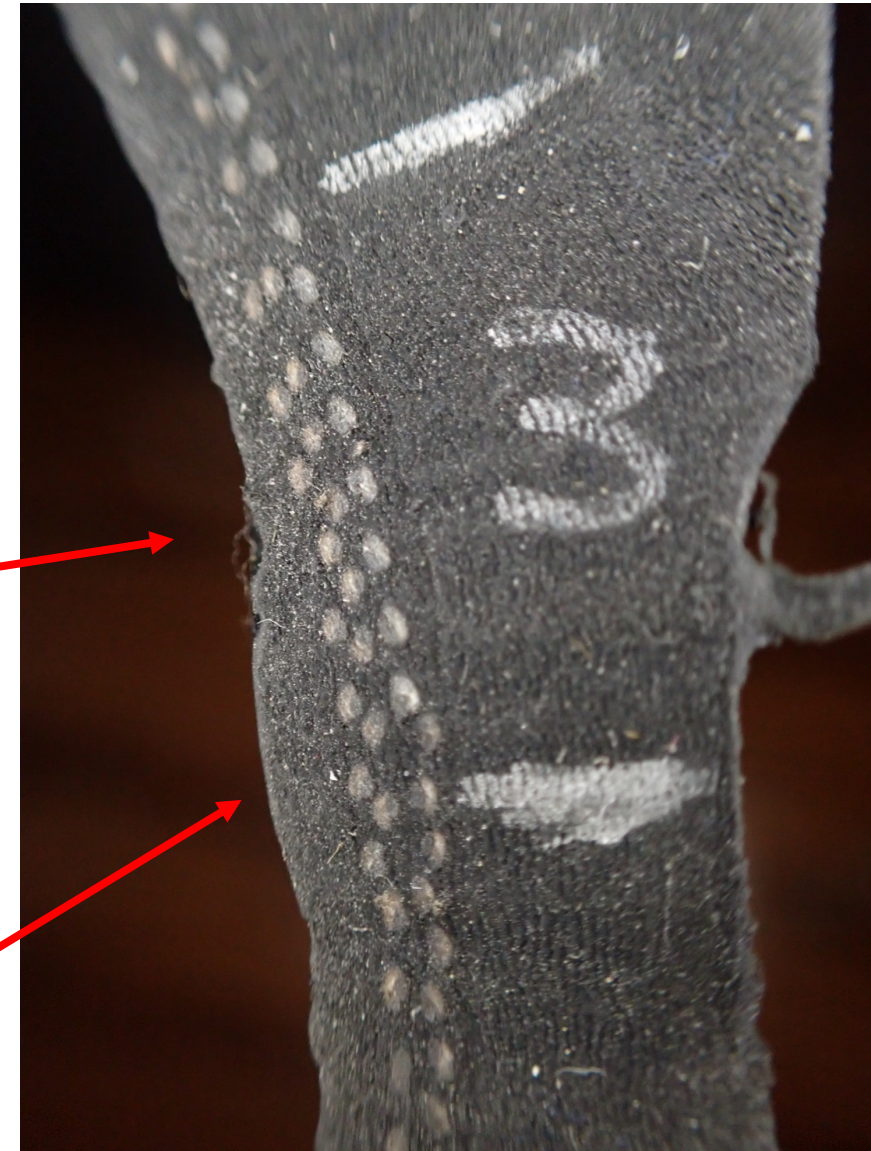
Splices occur at the building machine and during changeover from one spool to another.

Overall gauge in  
splice areas is  
increased by inner  
liner rib.

Interface D splice-~3 cord overlap

Interface A splice-~8 cord overlap

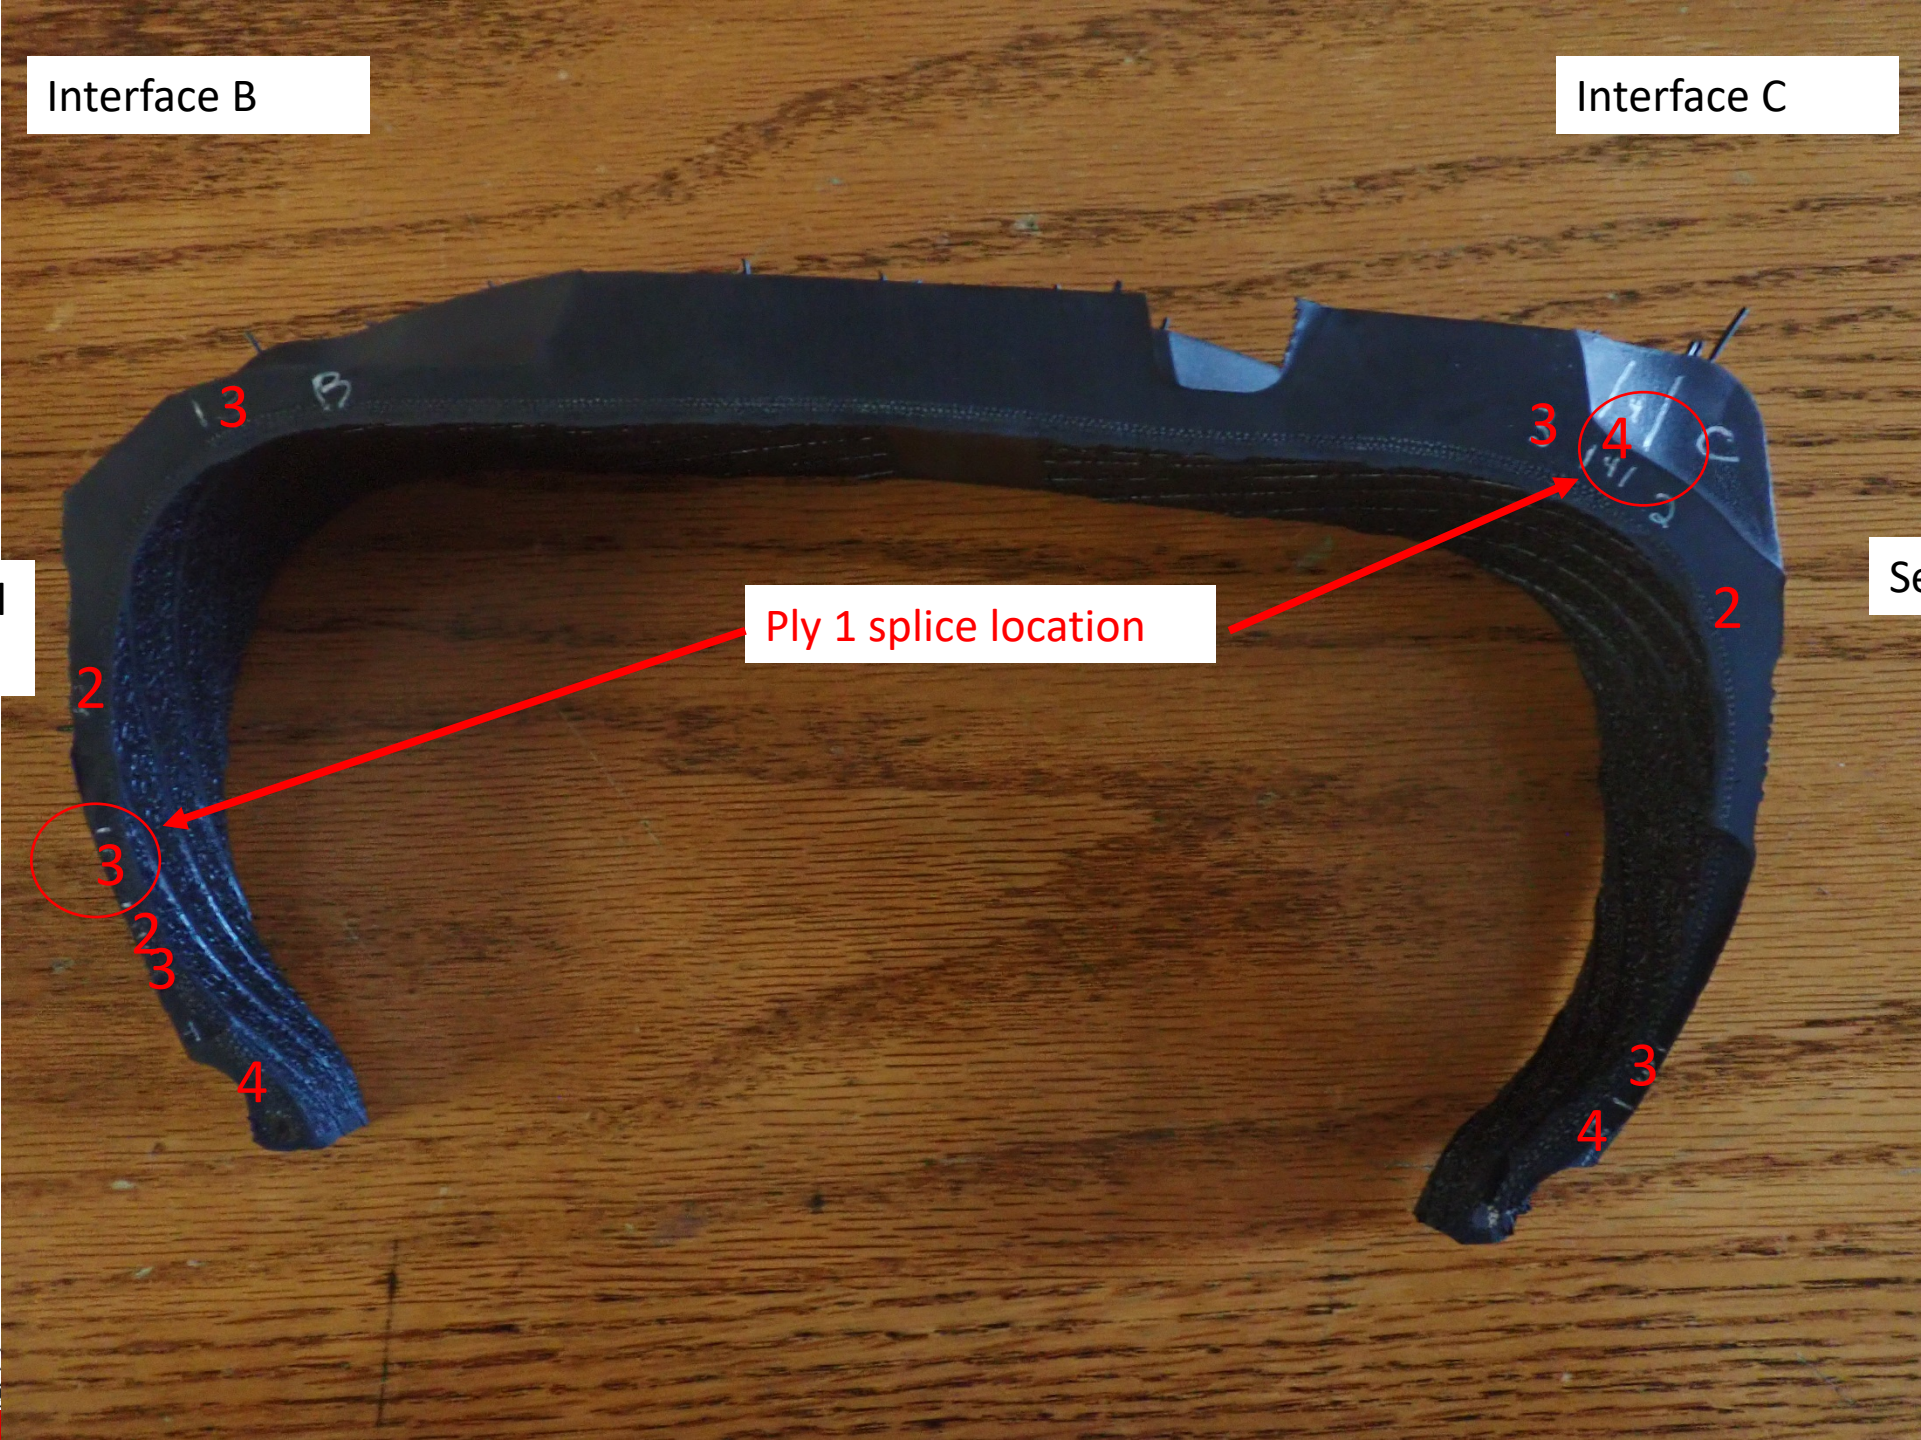
Ply 1 splice location

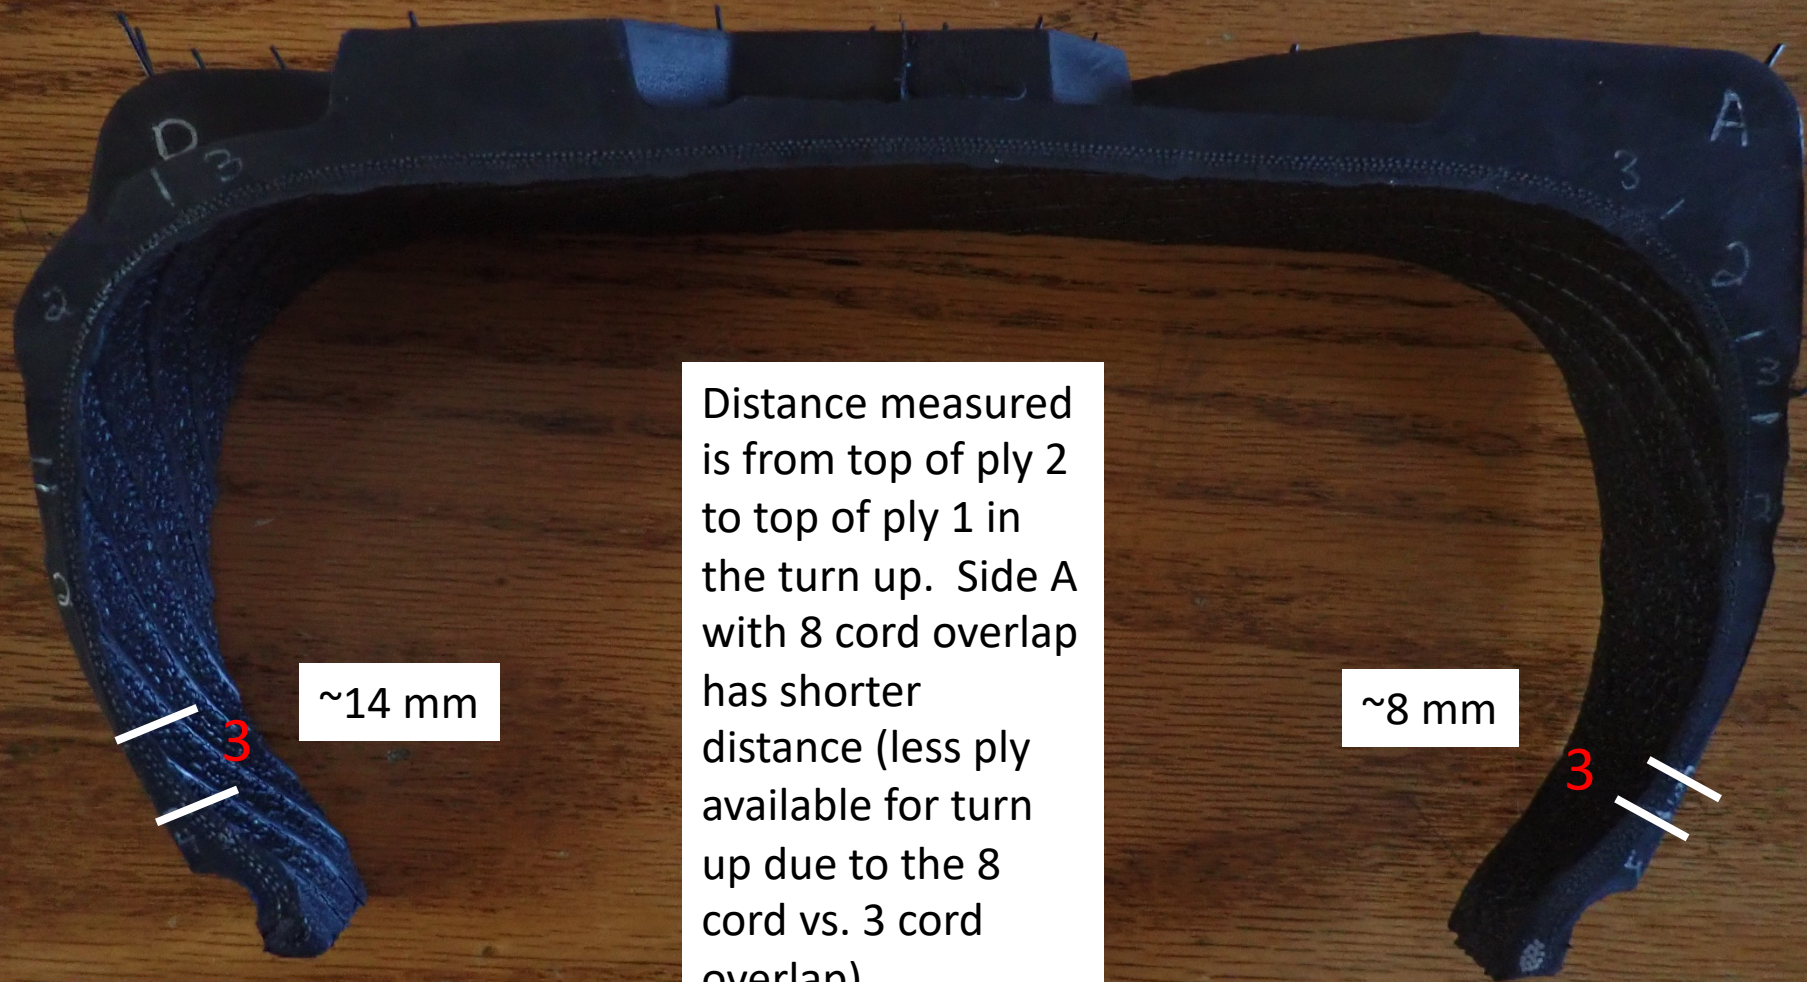
Distance measured is from top of ply 2 to top of ply 1 in the turn up. Side A with 8 cord overlap has shorter distance (less ply available for turn up due to the 8 cord vs. 3 cord overlap).

Root Cause-Manufacturing Error

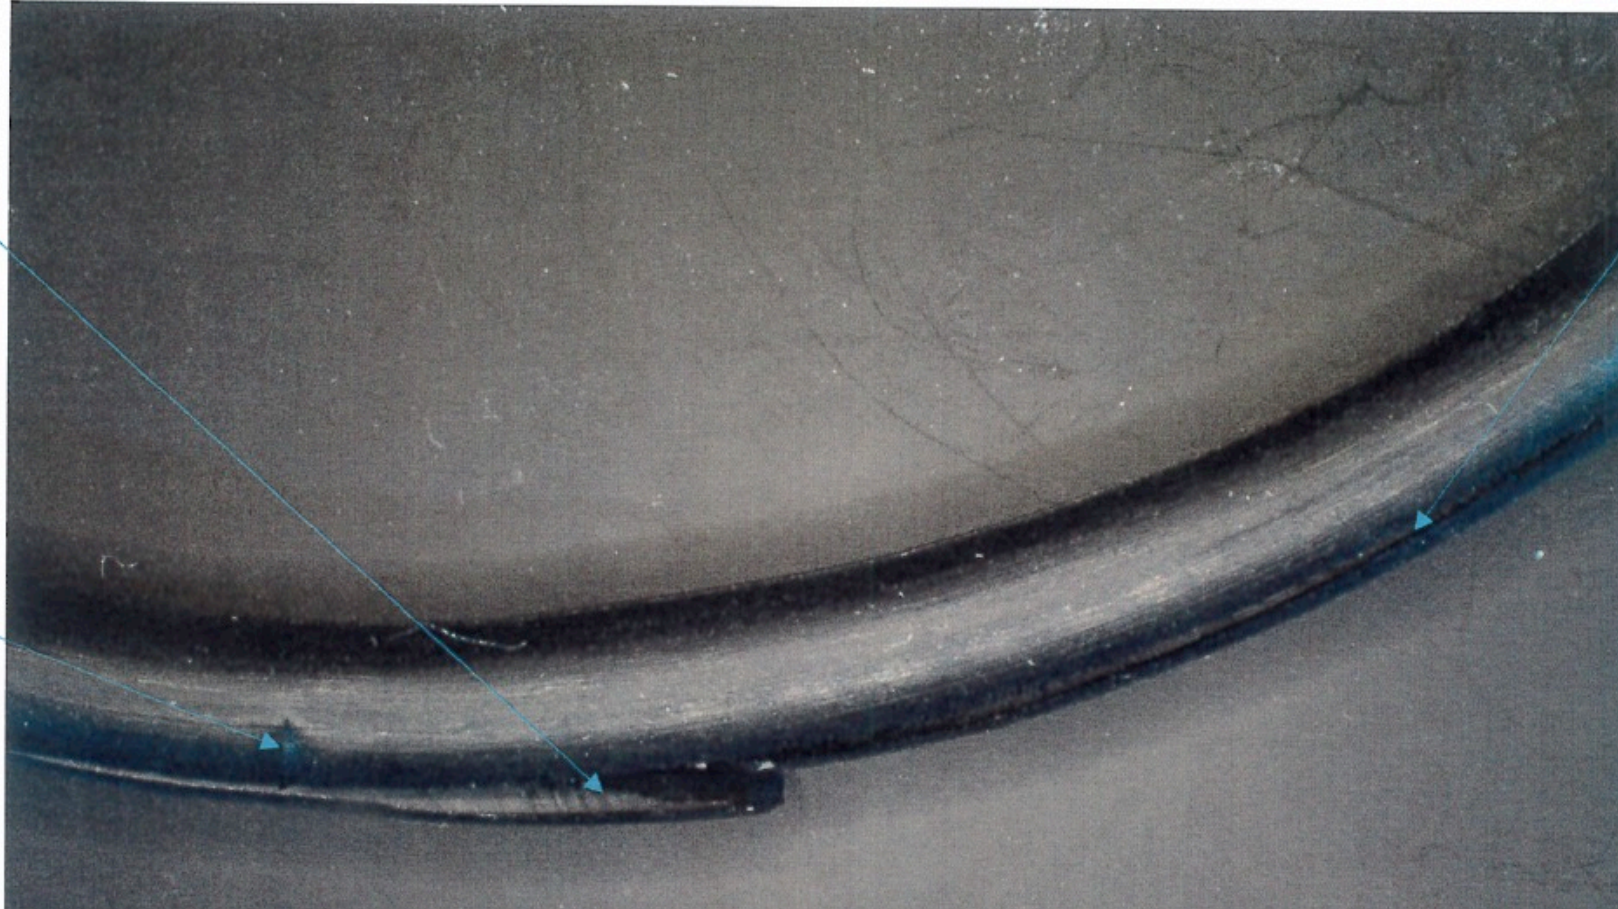
Tear in O-Ring

Crack in O-Ring

Pinch in O-Ring

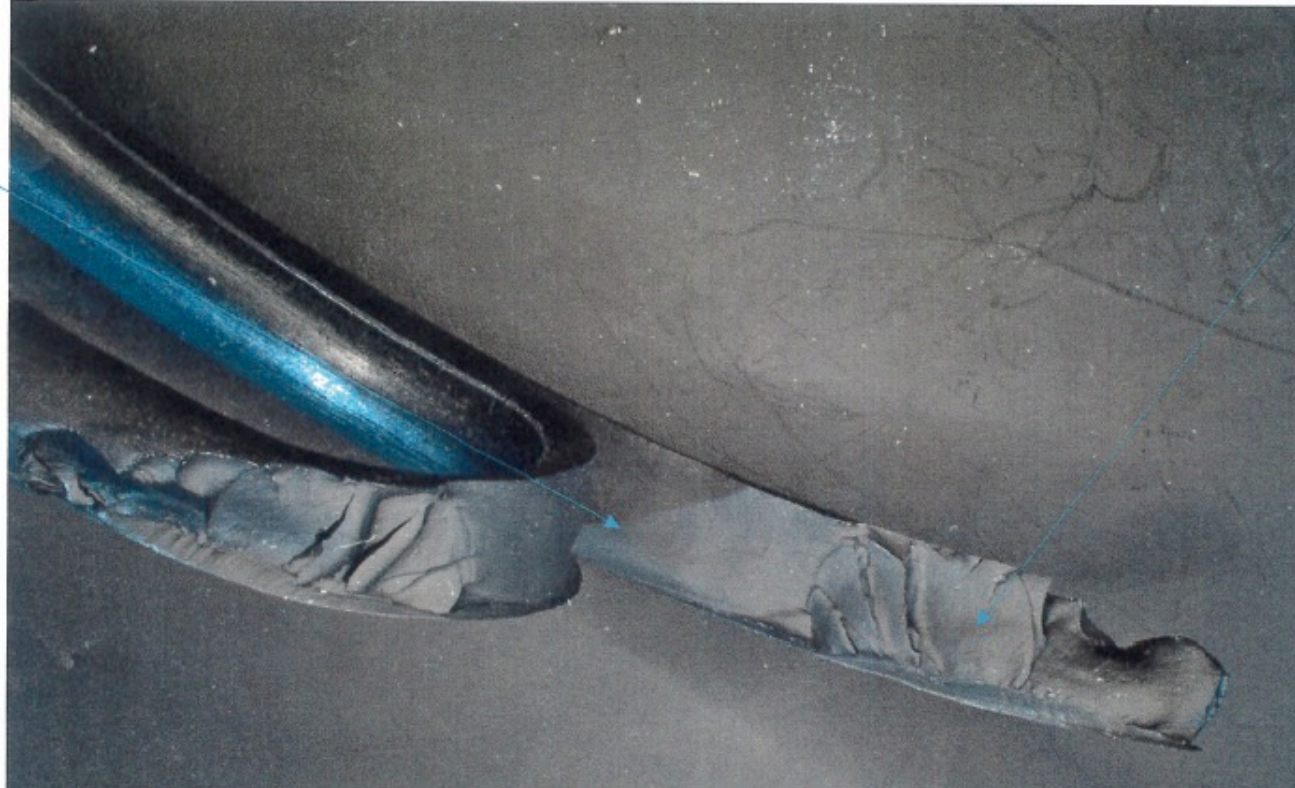
Smooth Quick Tear  
in O-Ring

Rough Slow  
Tear in  
O-Ring

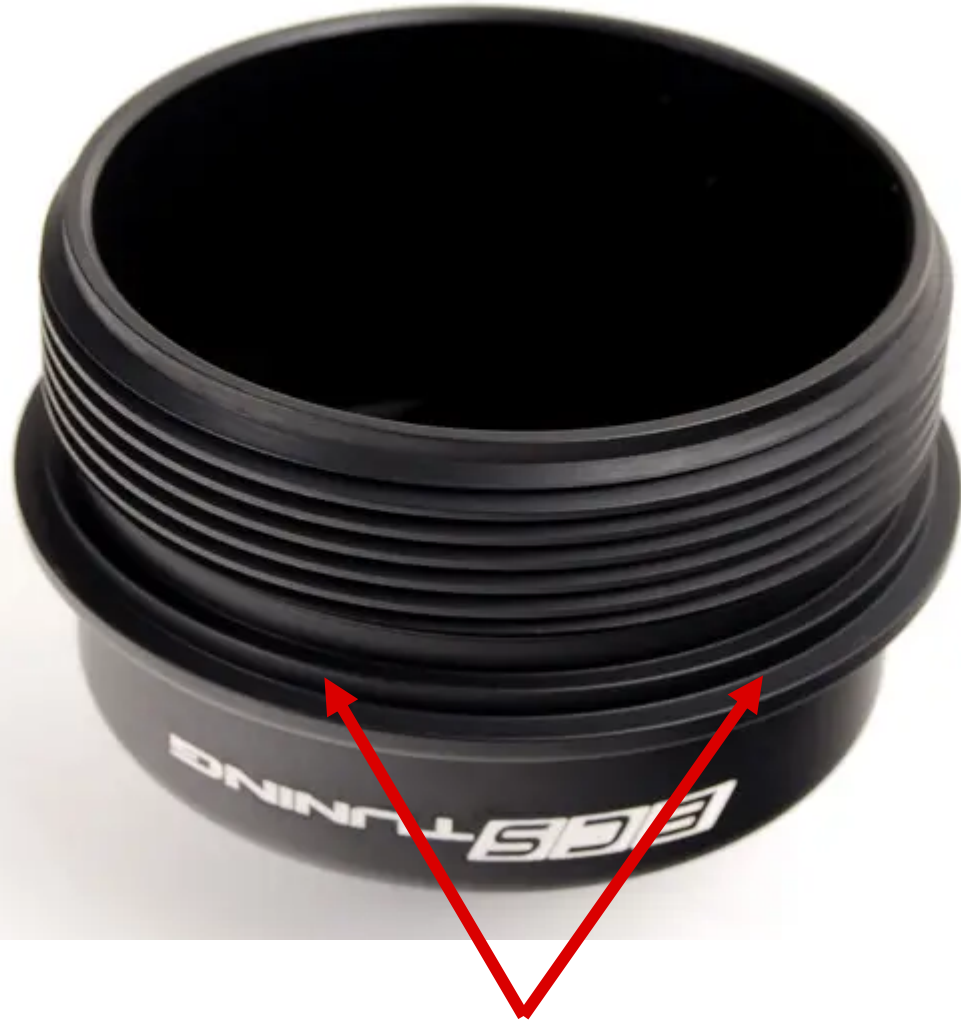
Smooth Quick Tear  
in O-Ring

Rough Slow  
Tear in  
O-Ring

- Misalignment of O-ring into O-ring groove during installation caused smooth tear
- After reaching operating oil pressure, the smooth tear slowly propagated to cause the rough tear surface
- After ~120 miles, rough tear progresses to the point of failure
- Root cause is human error

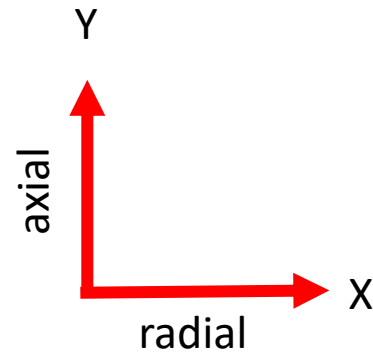
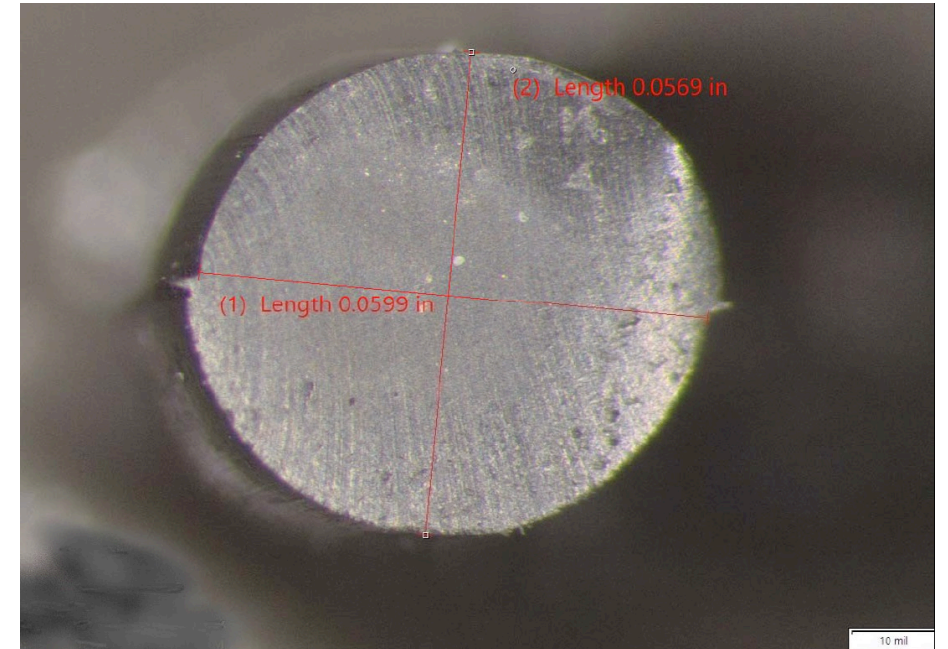
Top (axial) view gives only radial measurement

Cross section view gives both axial and radial measurements

Root cause-manufacturing defect

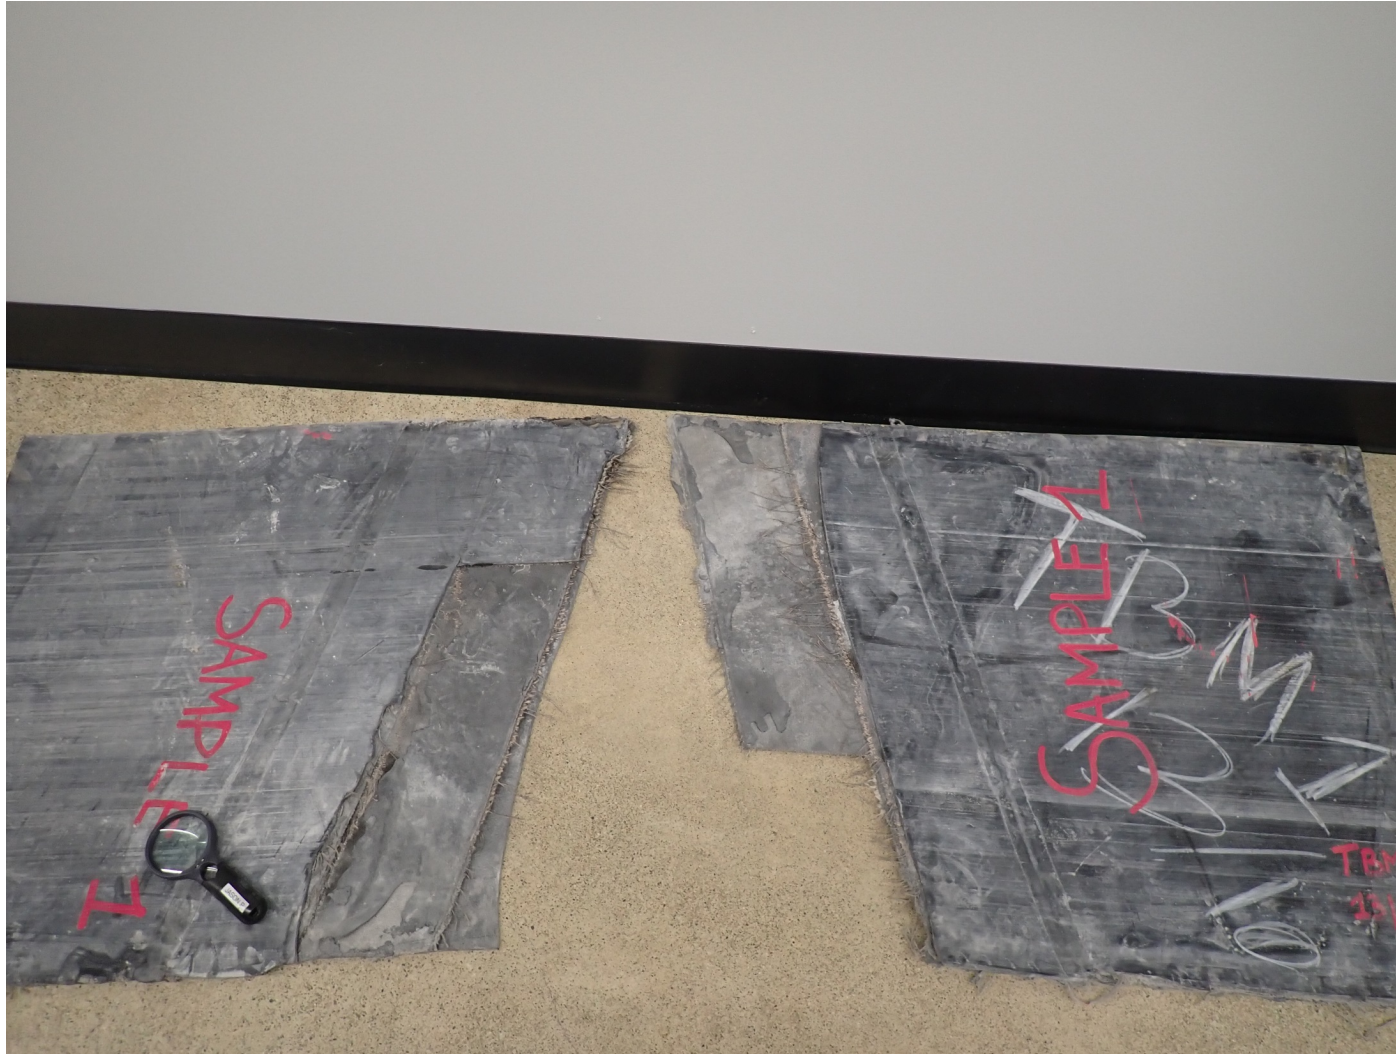
Sample 1-Failed splice from Supplier A

Root Cause-Human Error resulting in short splice length

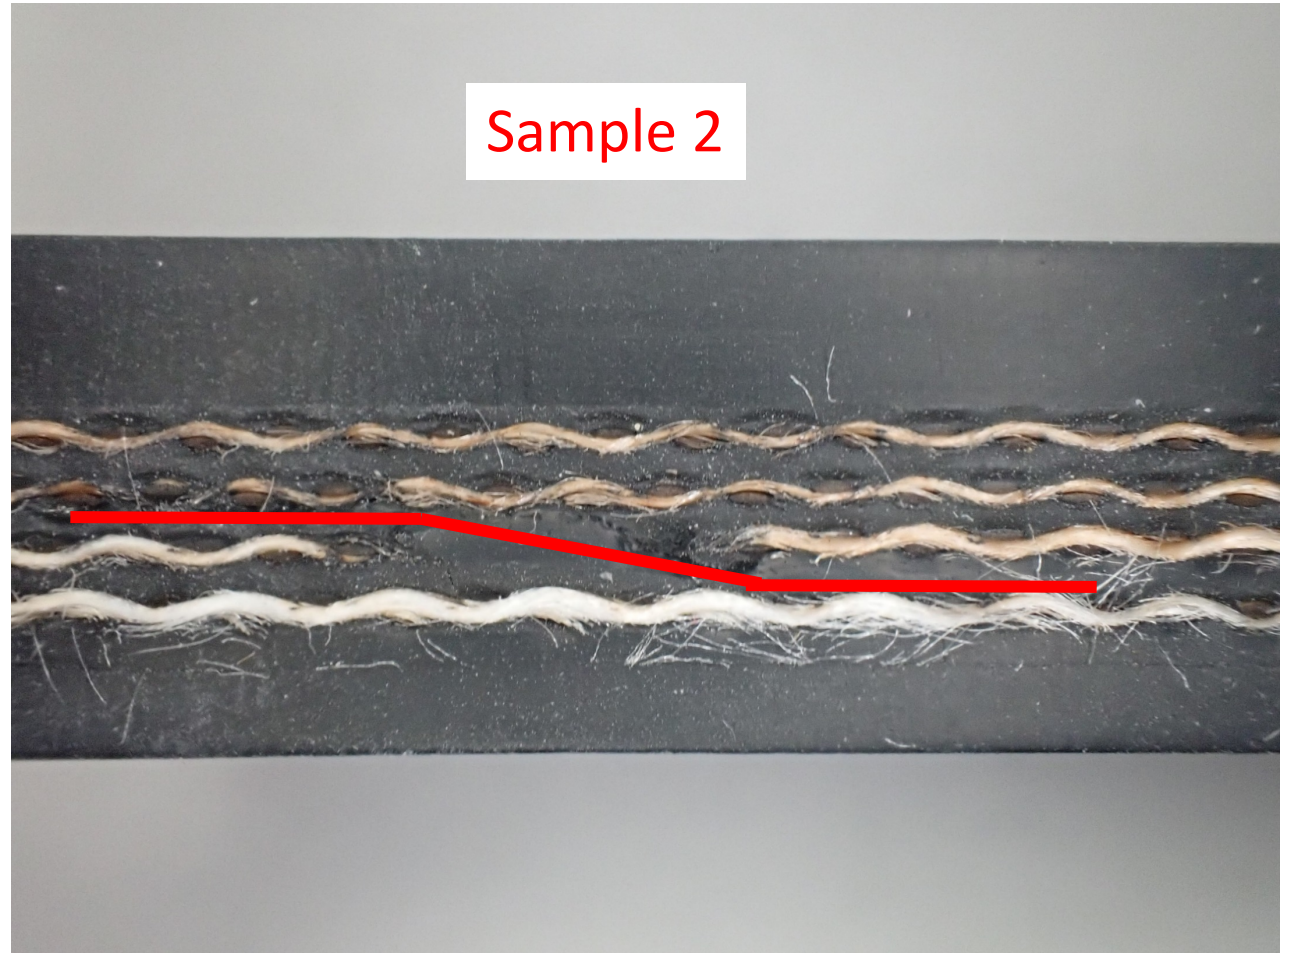
Sample 2

Sample 2-transition from fabric 2/fabric 3 splice to fabric 3/fabric 4 splice. Splice rubber marked with red lines.

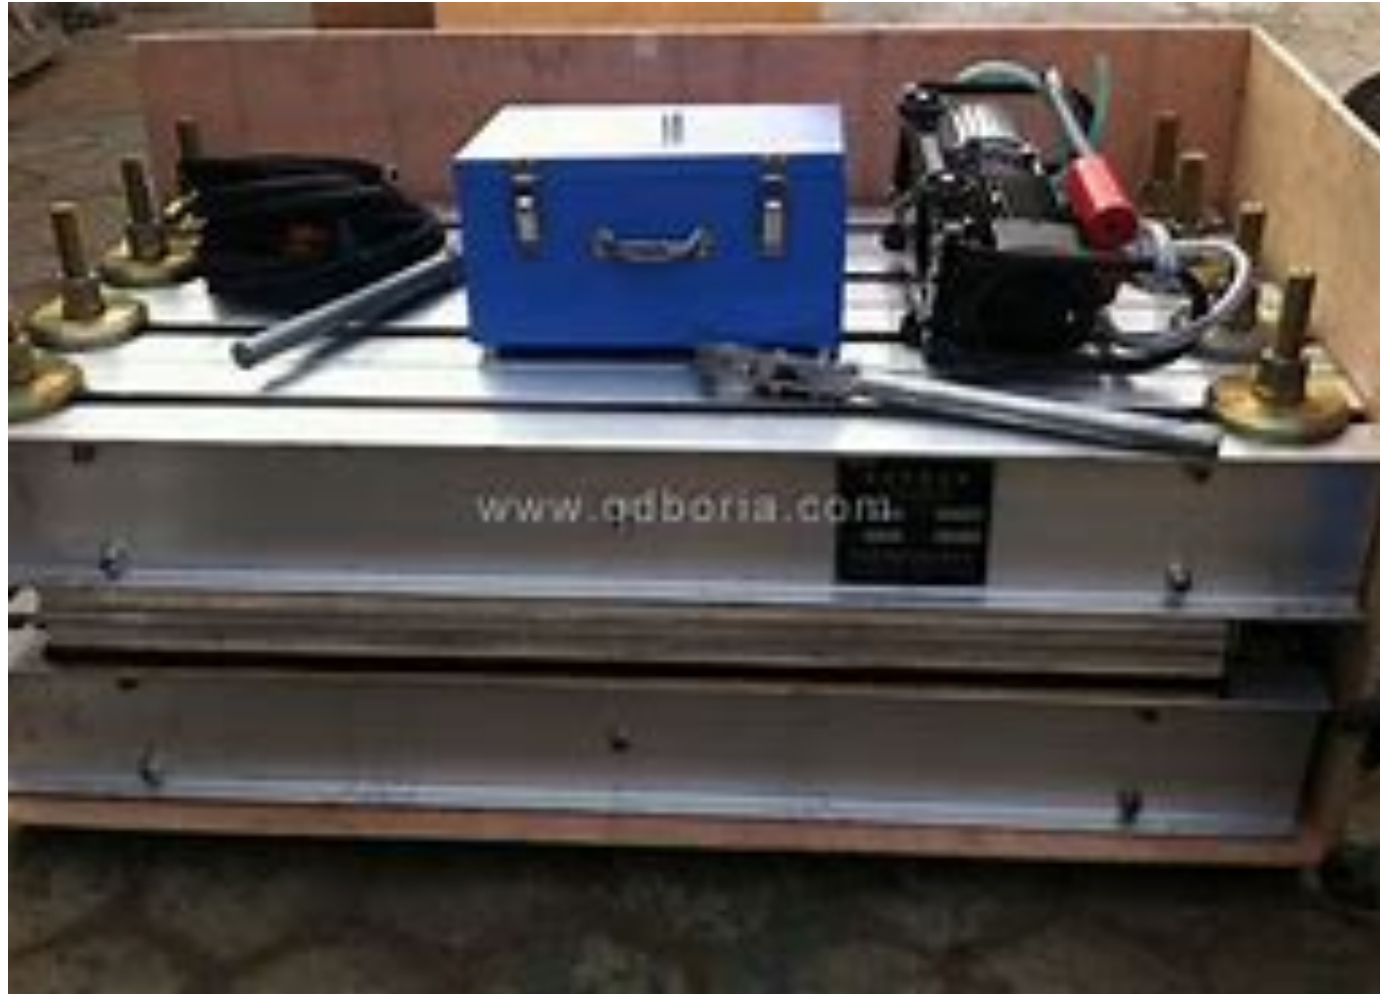
Why was the splice too short?-The length of the splice was determined by the width of the available portable curing press and not by the specifications.

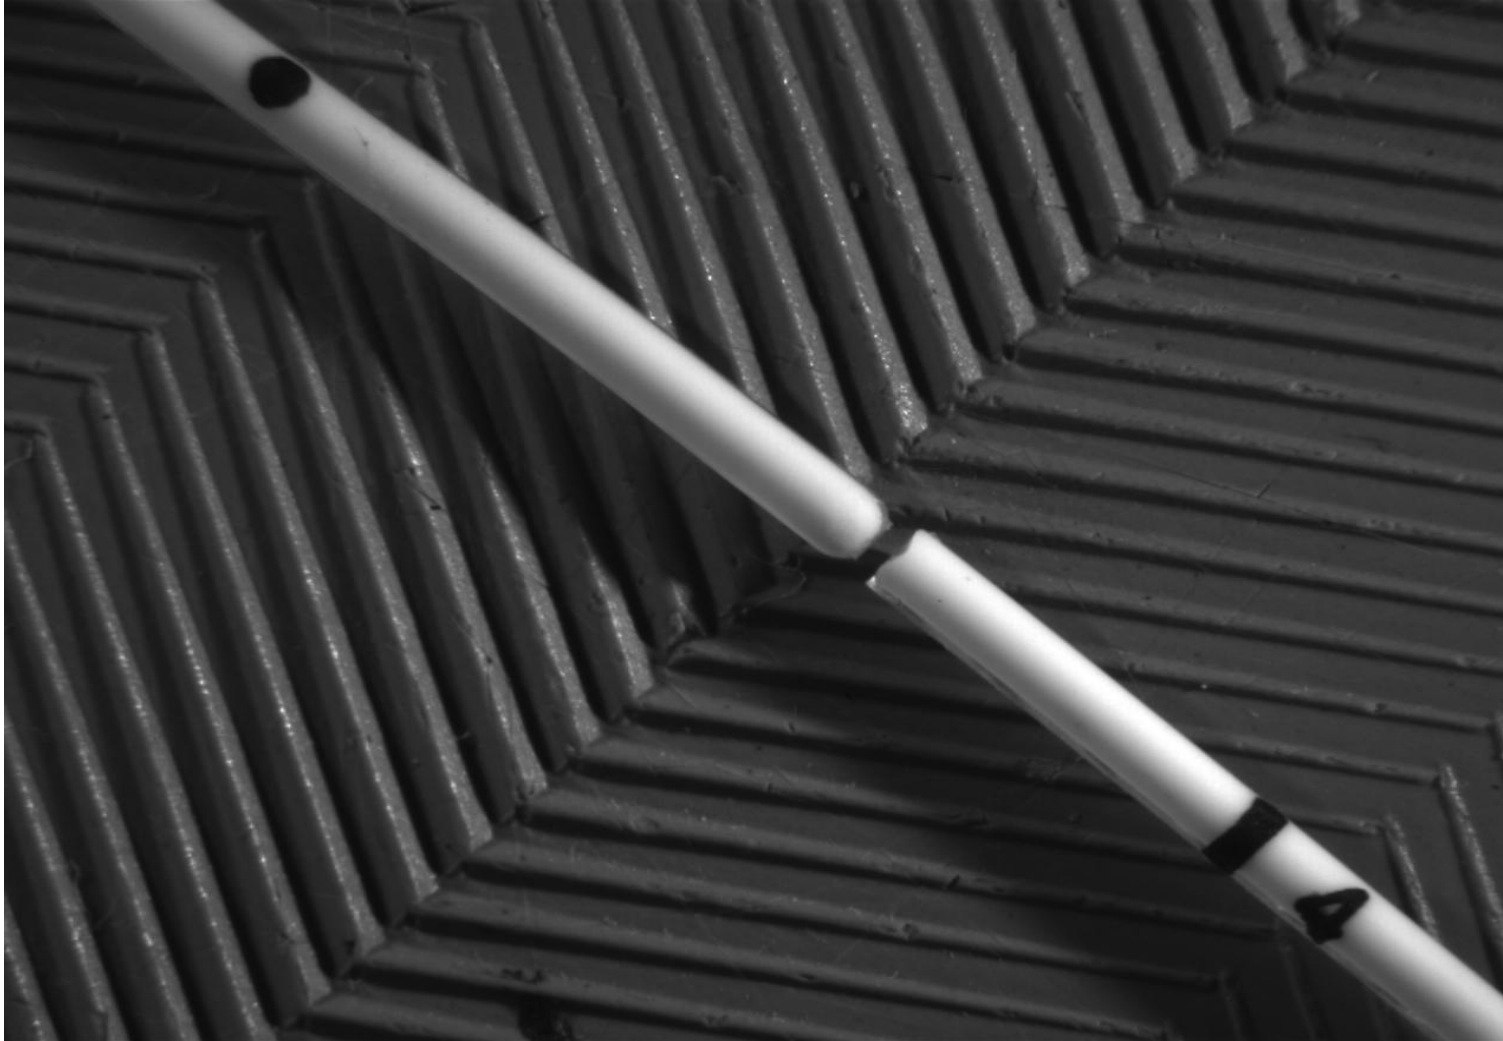
Incident Catheter point of failure, 5X Magnification.

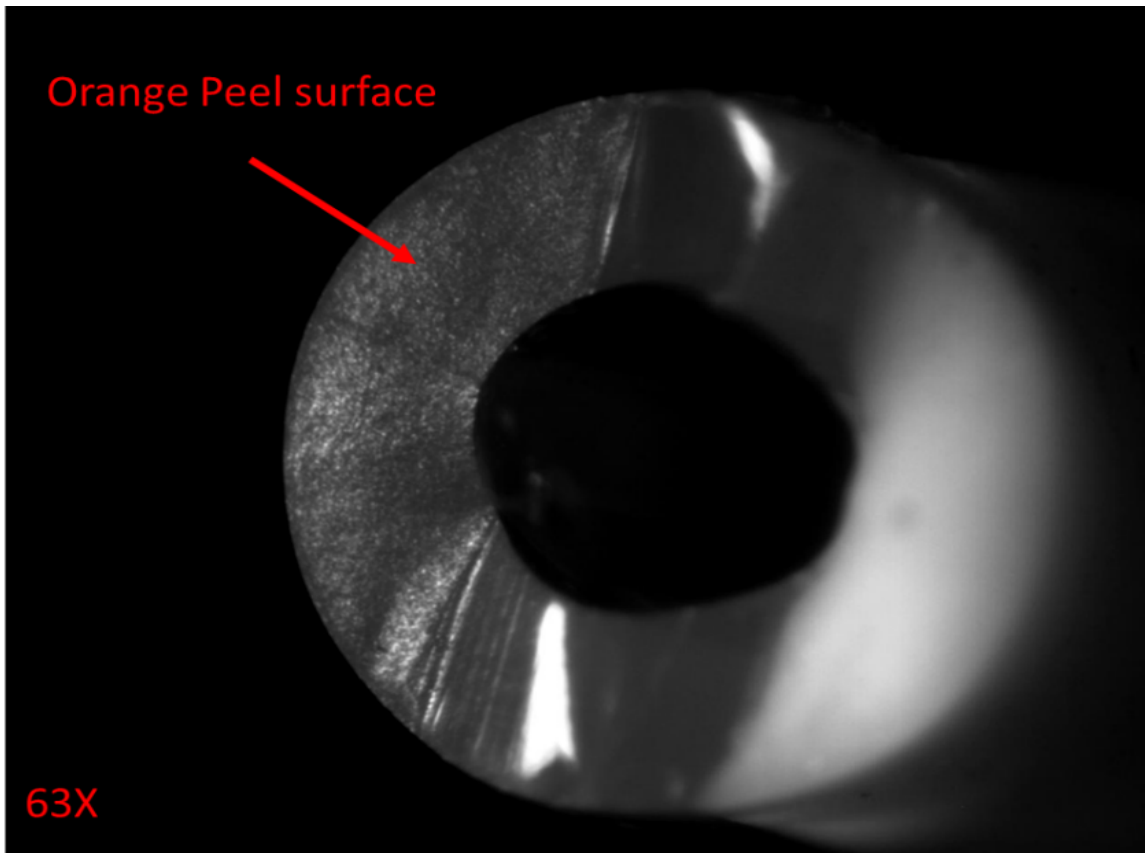
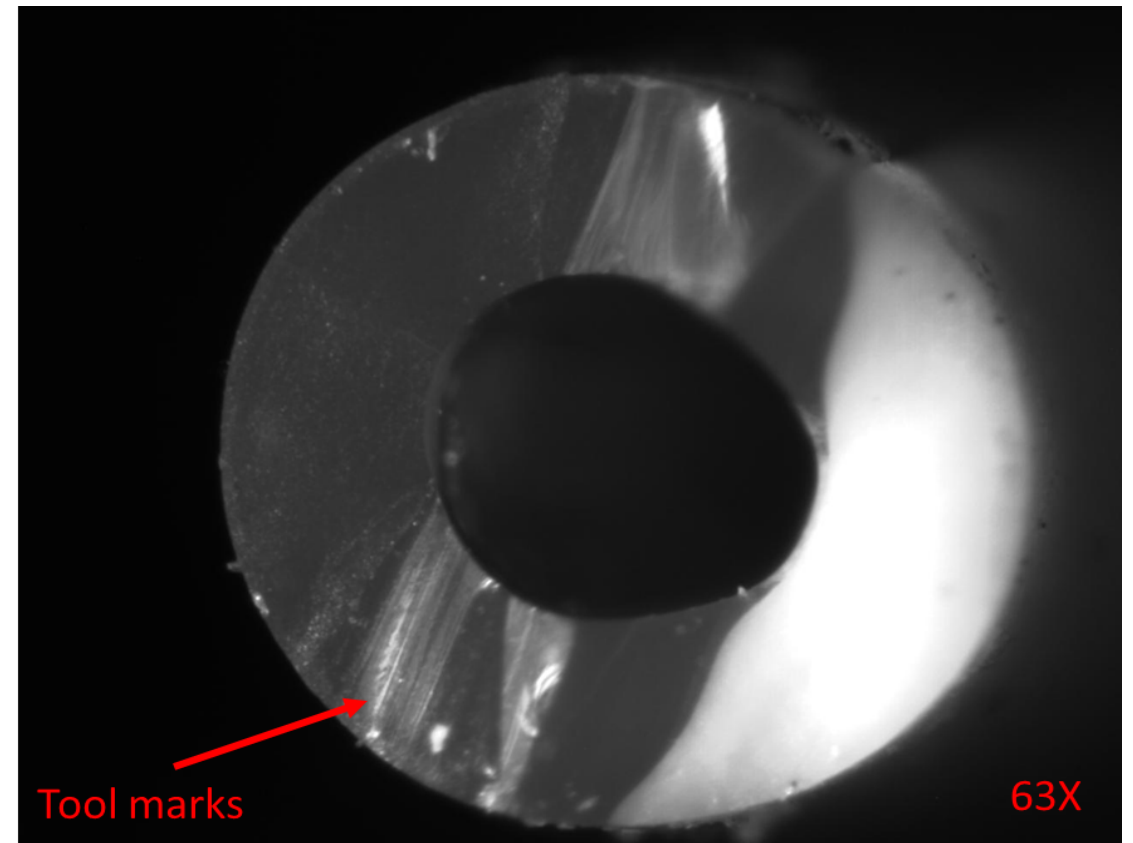
Fracture surface features of Incident Catheter
