# General Considerations in Failure Analysis of Rubber

Jason T. Poulton, PhD  
Senior Technical Advisor  
Akron Rubber Development Laboratory

# Akron Rubber Development Laboratory

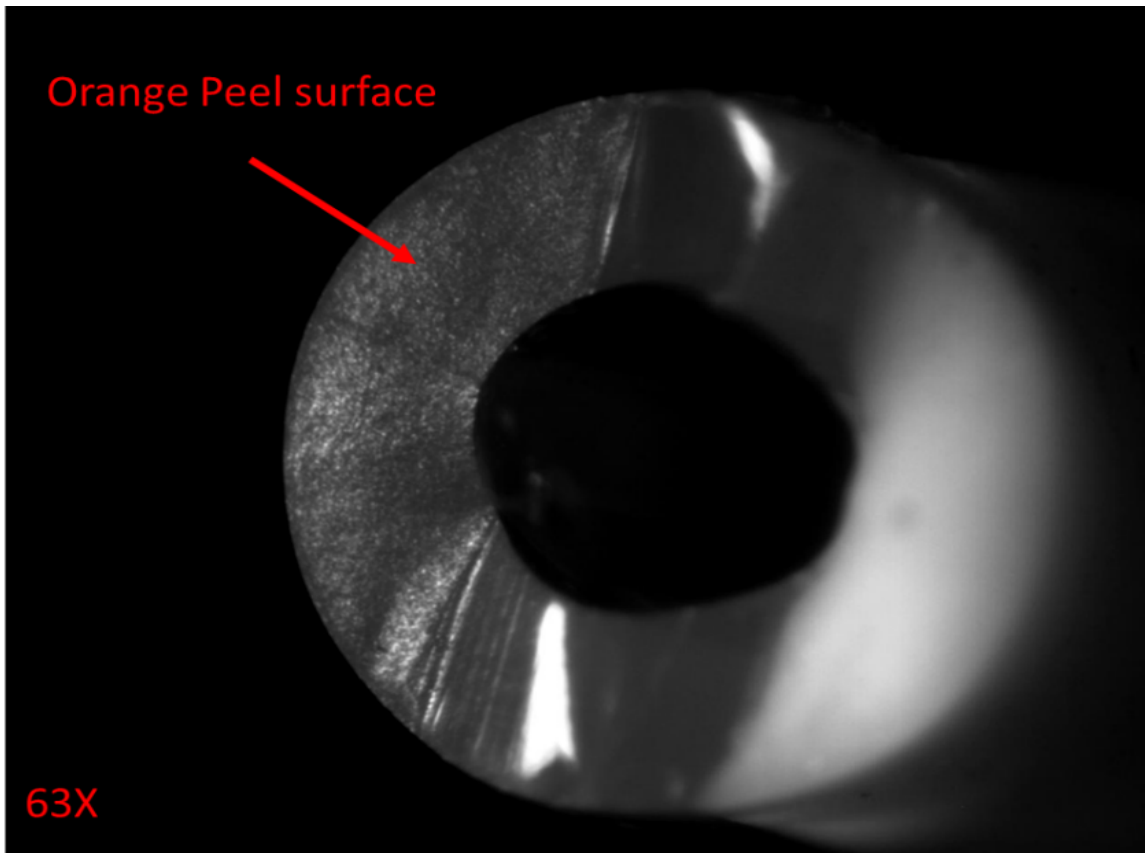
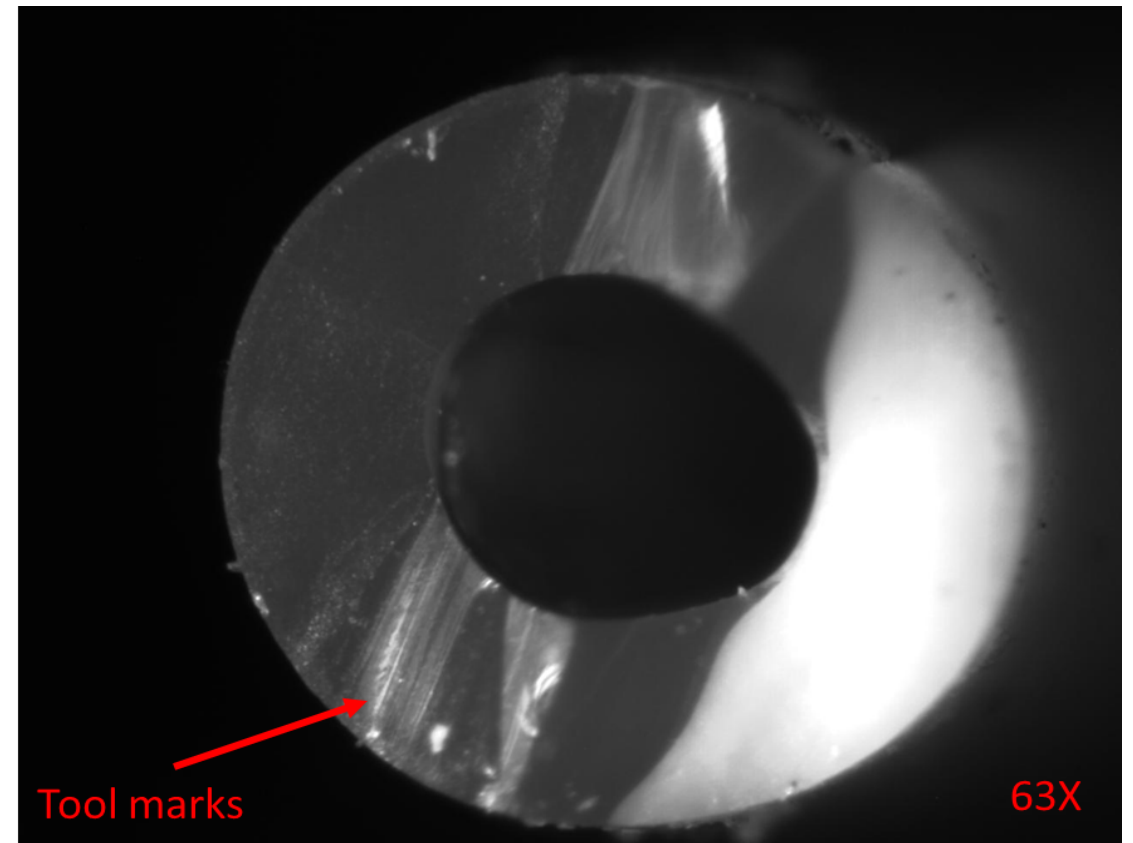
Fracture surface features of Incident Catheter
