# General Considerations in Failure Analysis of Rubber

Jason T. Poulton, PhD  
Senior Technical Advisor  
Akron Rubber Development Laboratory

# Akron Rubber Development Laboratory

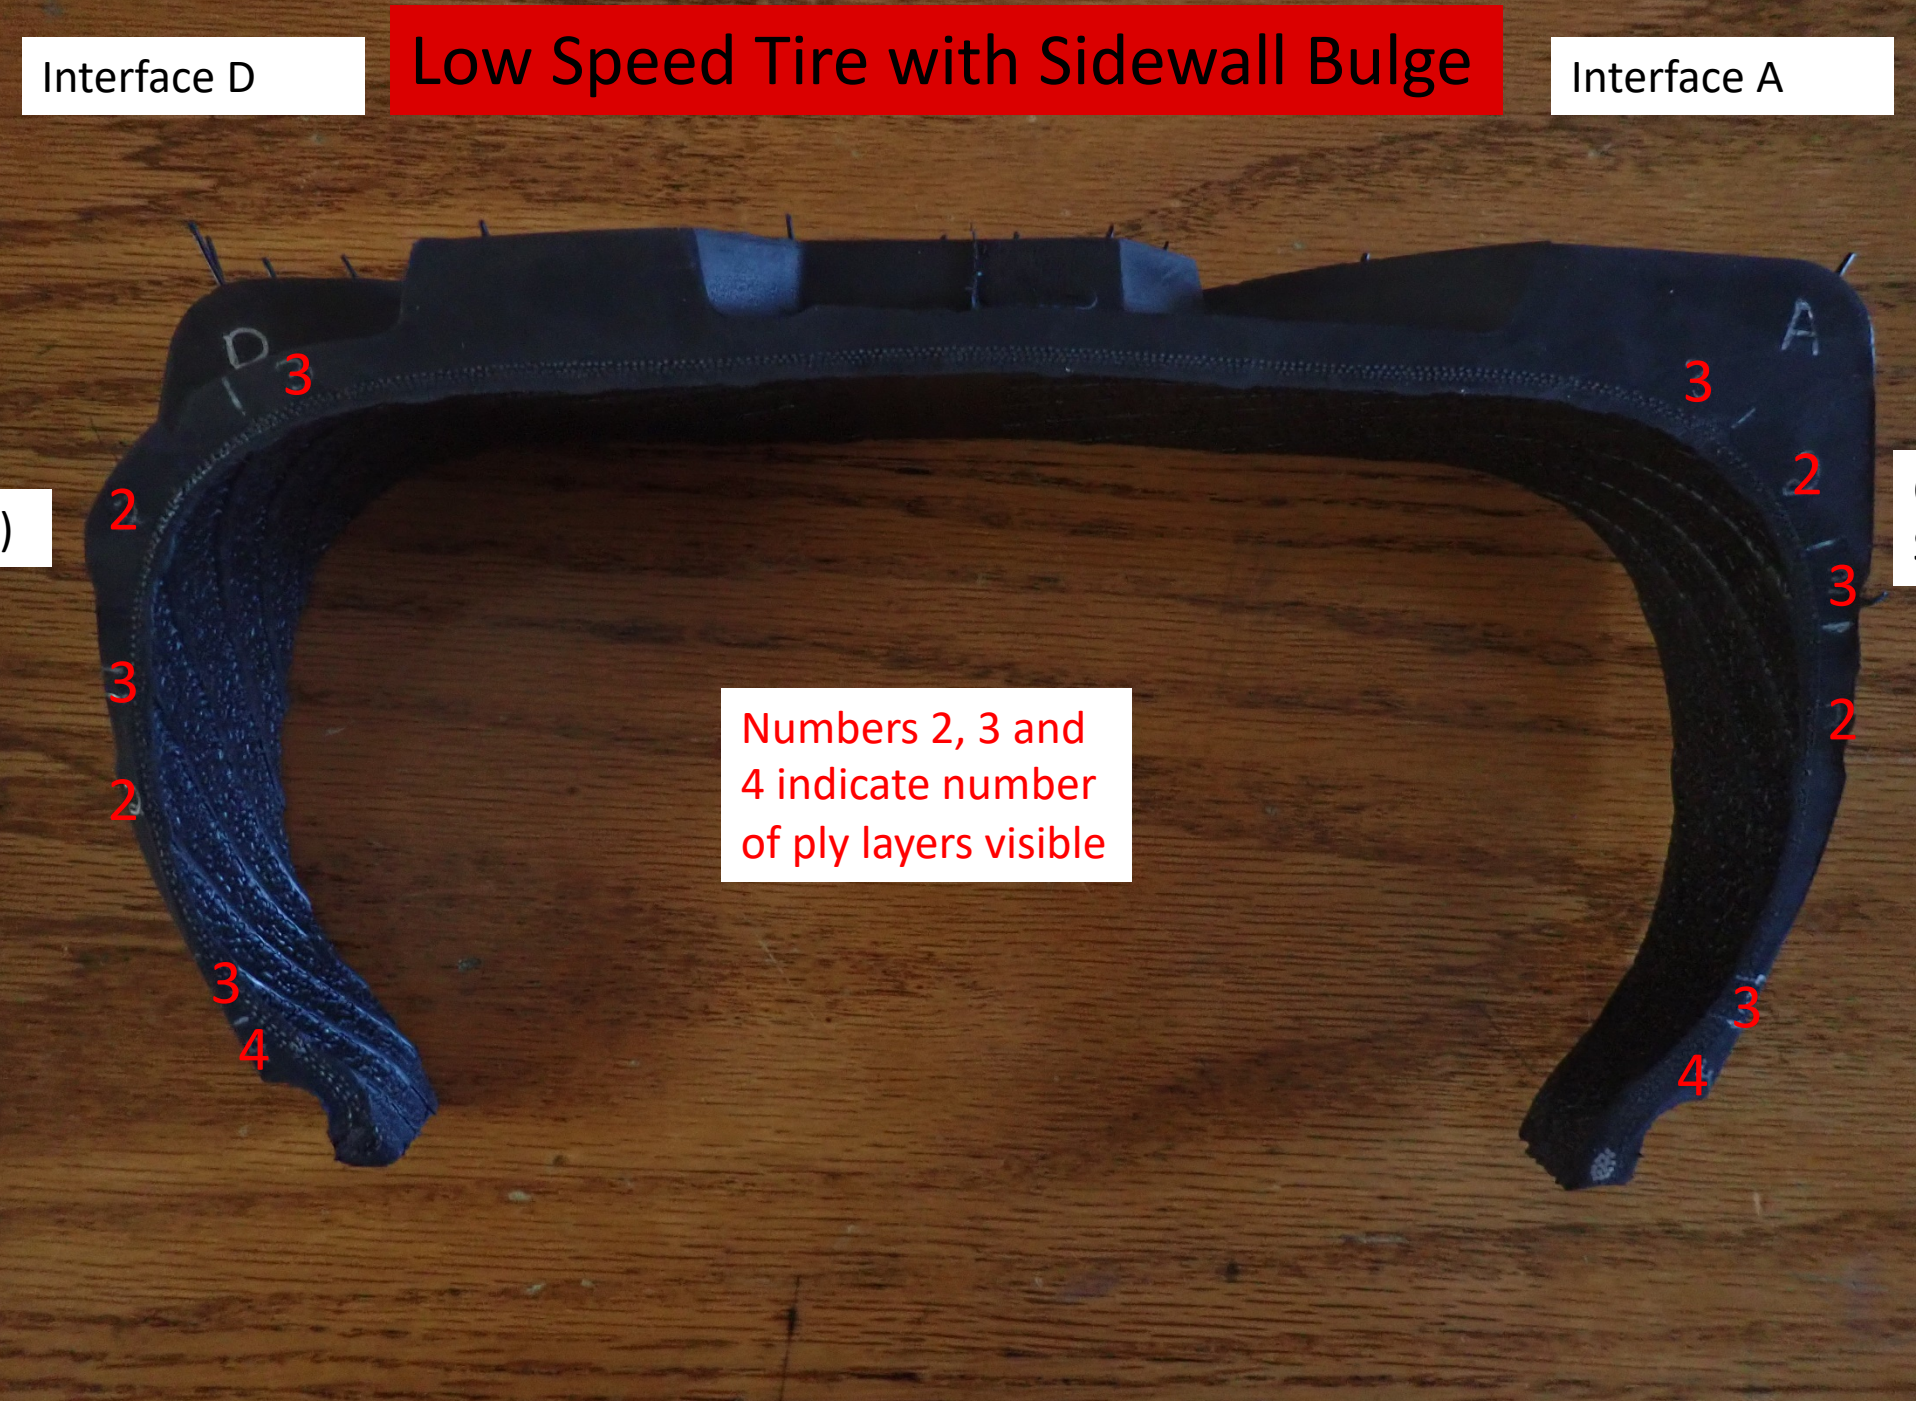
Numbers 2, 3 and 4 indicate number of ply layers visible

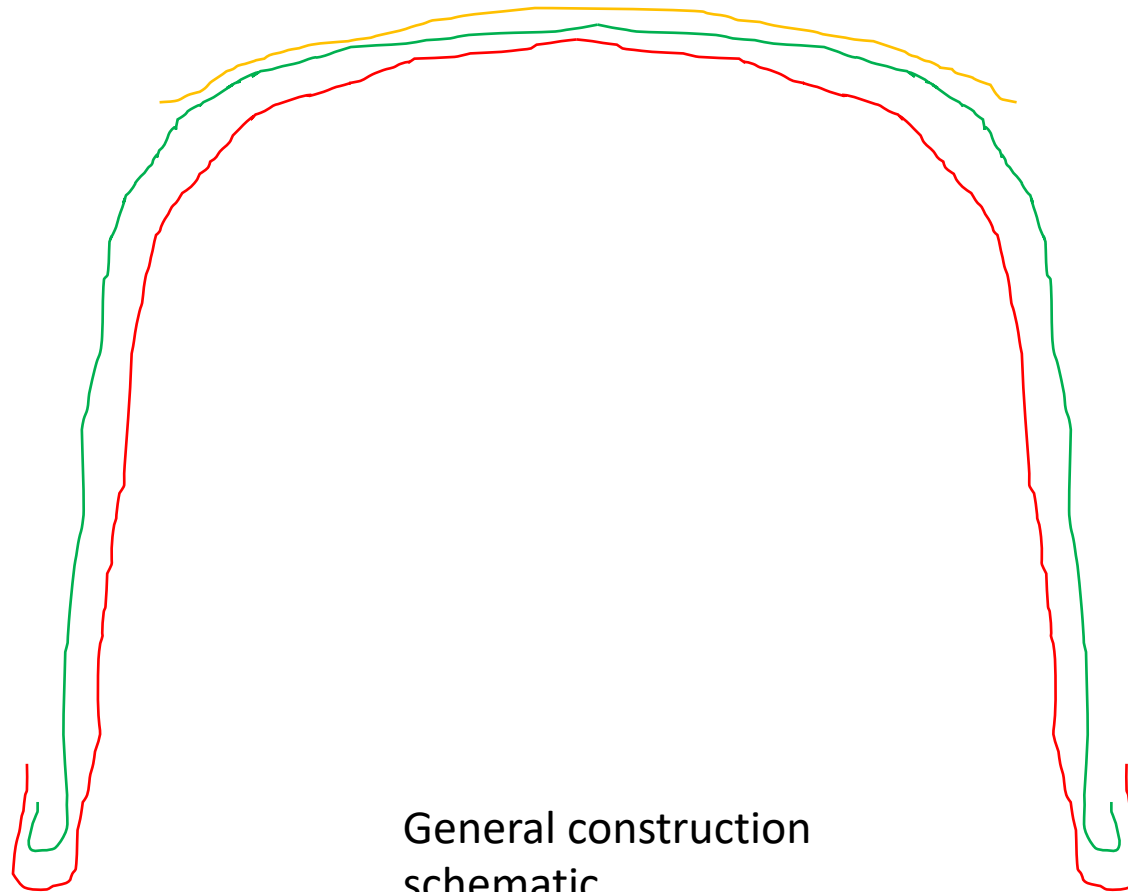
General construction  
schematic

- Ply 1 in red
- Ply 2 in green
- Ply 3 in orange

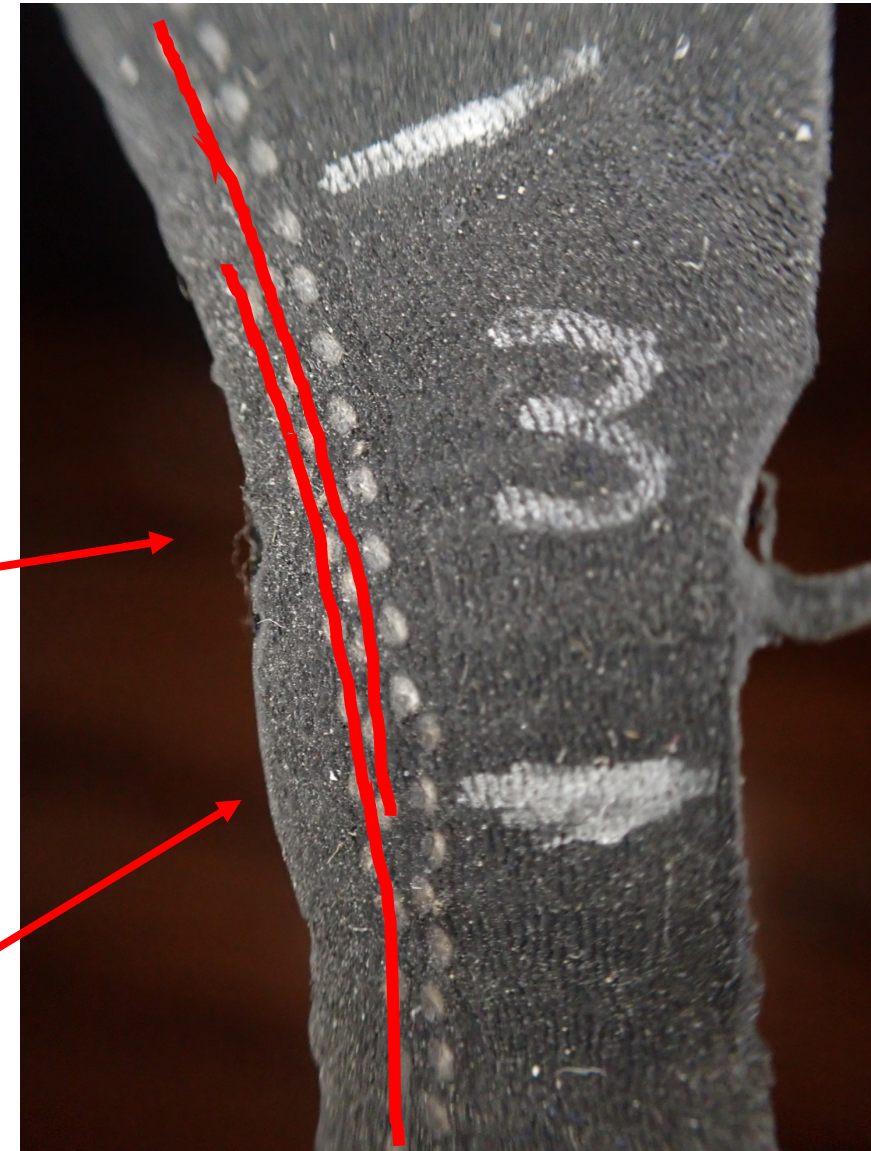
Overall gauge in splice areas is increased by inner liner rib.

Interface A splice-~8 cord overlap

Interface D splice-~3 cord overlap

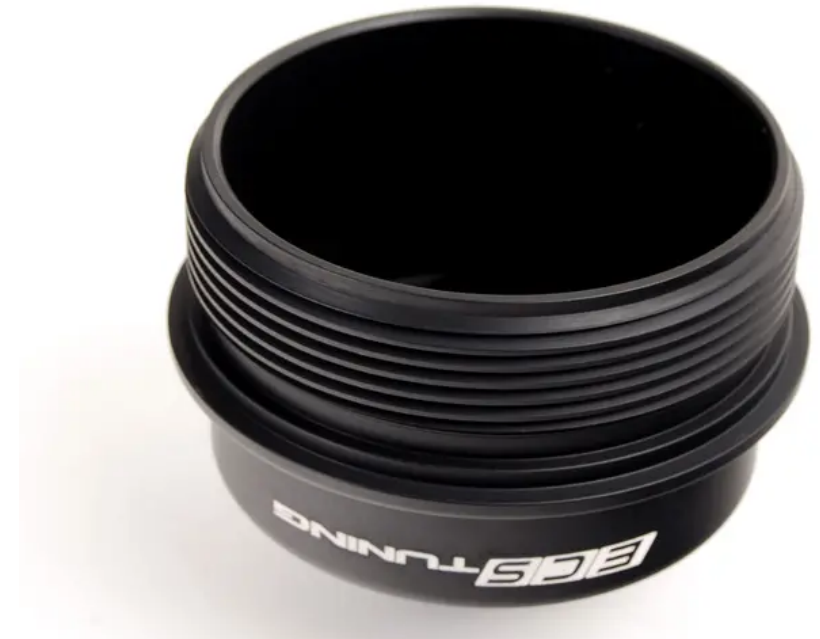
- Automobile Engine Oil Filter
- Filter suffered catastrophic failure ~120 miles after installation

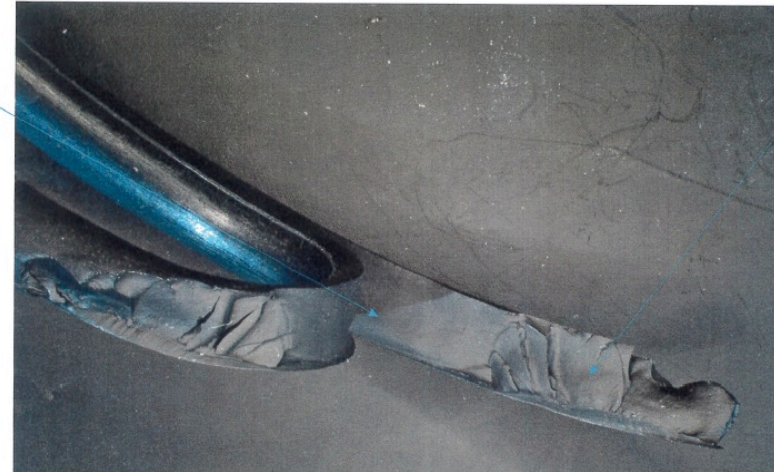
Smooth Quick Tear  
in O-Ring

Rough Slow  
Tear in  
O-Ring

- Misalignment of O-ring into O-ring groove during installation caused smooth tear
- After reaching operating oil pressure, the smooth tear slowly propagated to cause the rough tear surface
- After ~120 miles, rough tear progresses to the point of failure
- Root cause is human error

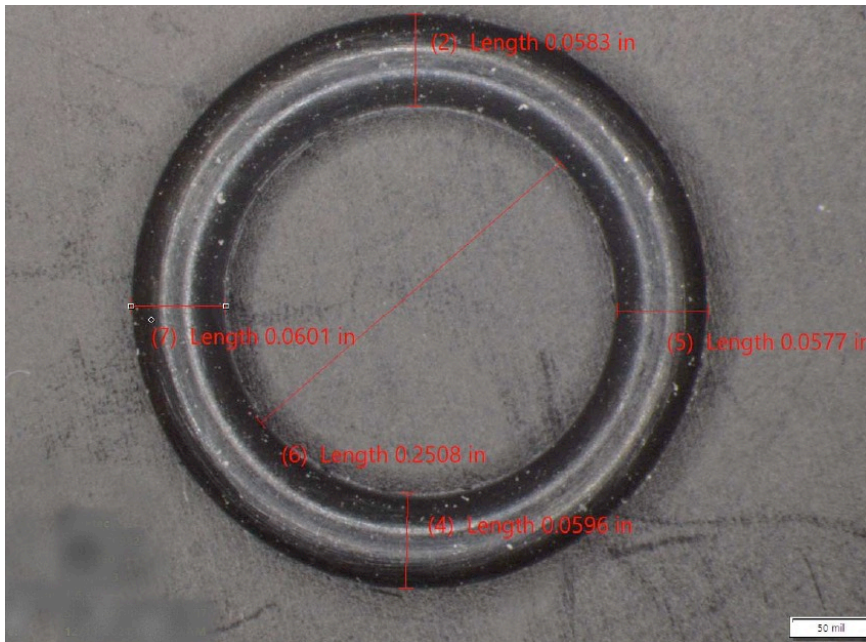
Top (axial) view gives only radial measurement

Cross section view gives both axial and radial measurements

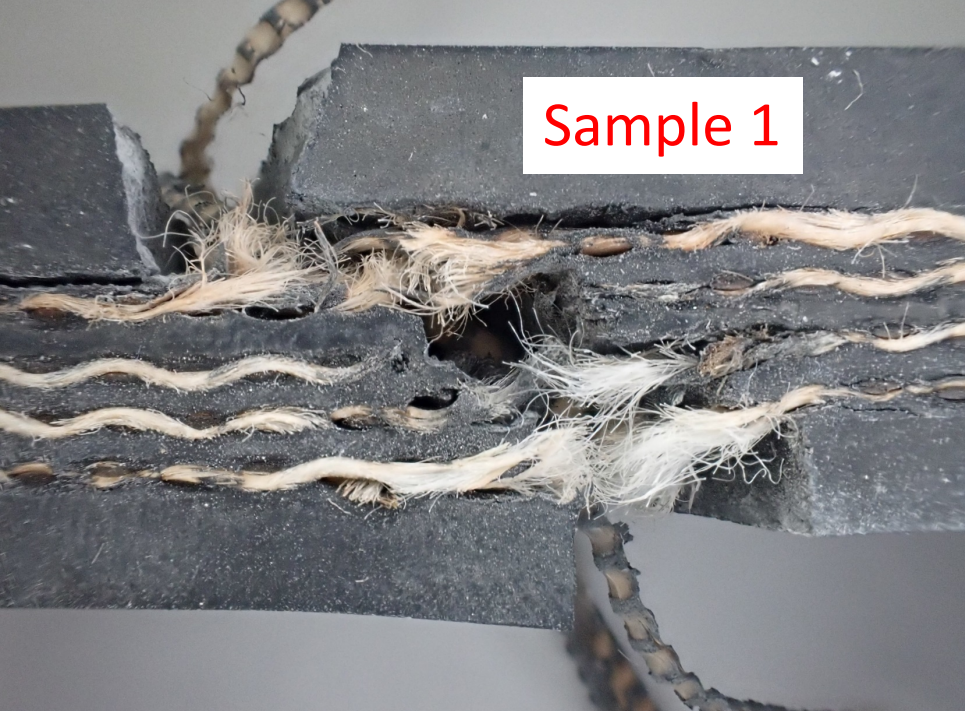
Sample 1

Is the splice rubber properly cured?

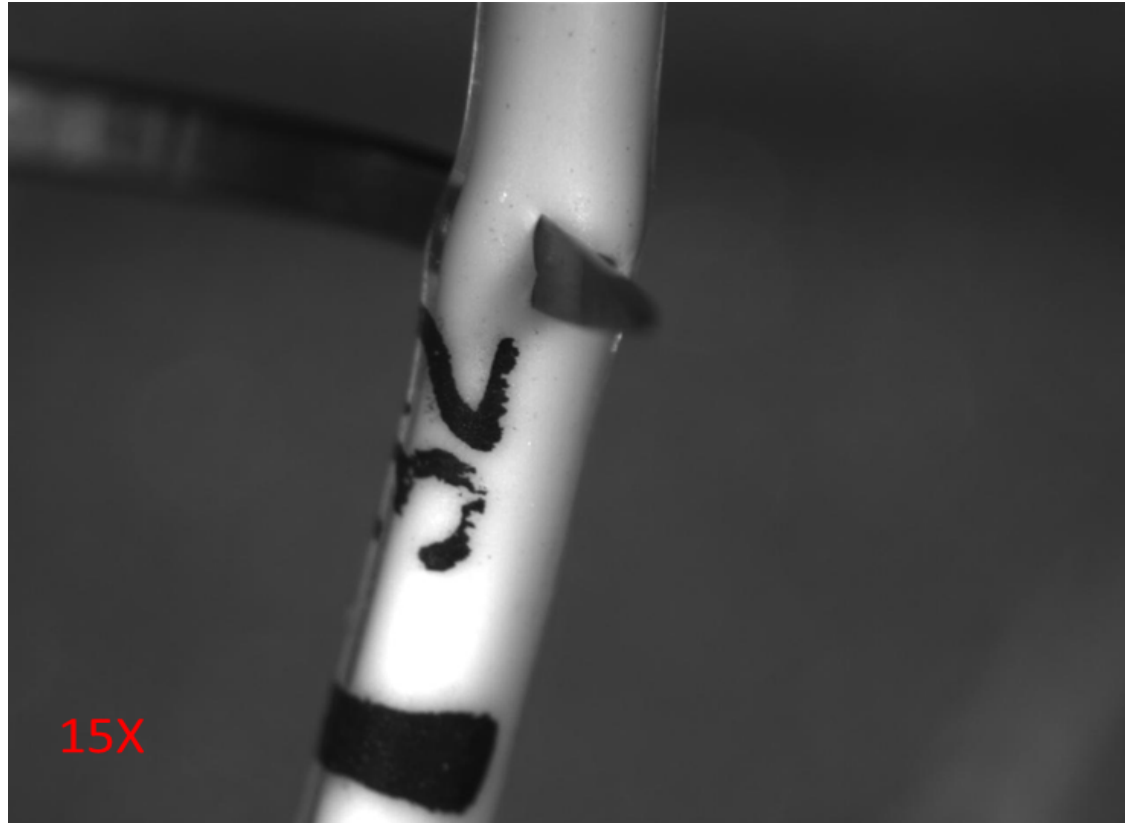
Exemplar catheter punctured with suture needle.

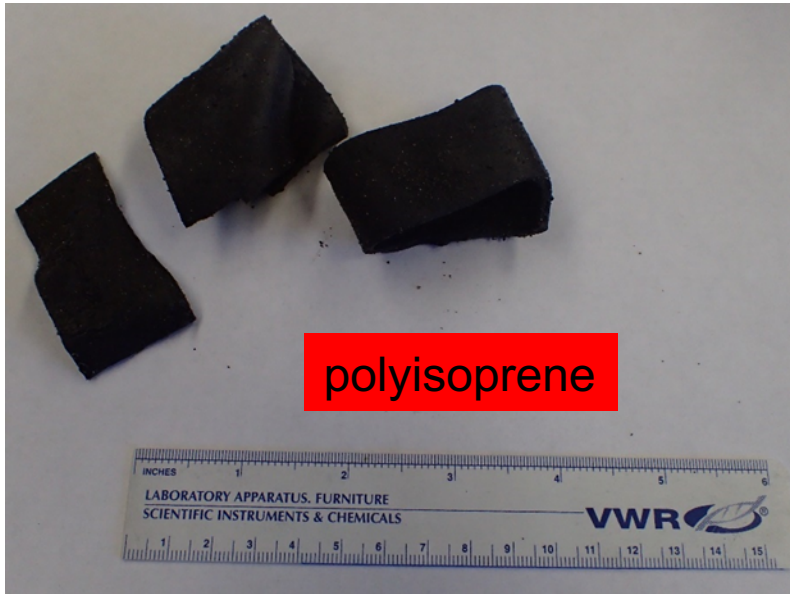
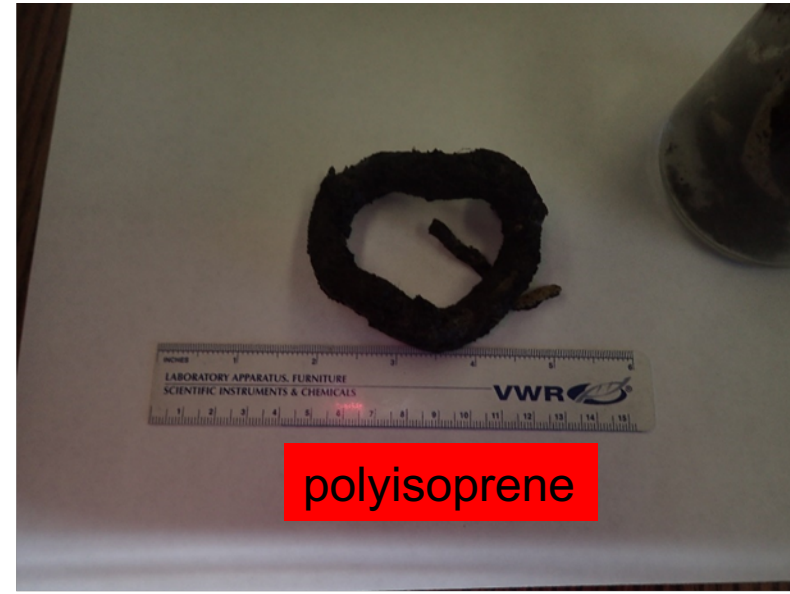
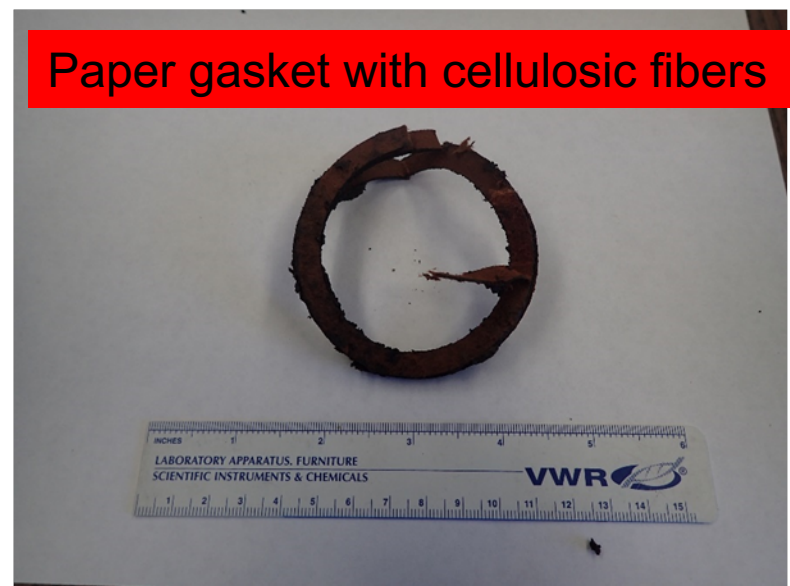
Polymer identification by FT-IR was selected as first step.
